Safe Then; Safe Now

A Summary of Pueblo Dam's History

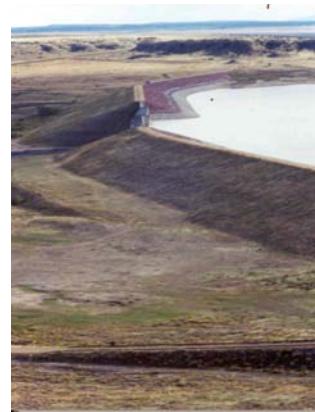
The long earthen embankment at Pueblo Dam.

Pueblo is an earthen embankment dam, with a center concrete section that supports a large spillway. The spillway is designed to *safely* pass floodwaters that would otherwise overflow the dam. When filled to the spillway crest, Pueblo Reservoir holds 349,940 acre feet of water.

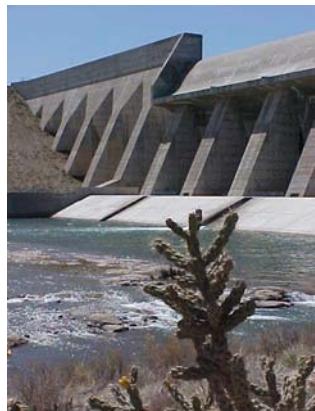
The concrete spillway at Pueblo Dam

In 1997, a review of Pueblo Dam identified a slight possibility that the concrete spillway section of the dam could slide under high loading conditions—a lot of pressure behind the dam. Actions were taken to prevent the possibility of sliding. Those actions included:

- Filling a portion of the stilling basin with roller-compacted concrete (RCC)
- Installing rock bolts through the toe block and the foundation layers to further anchor the concrete section.

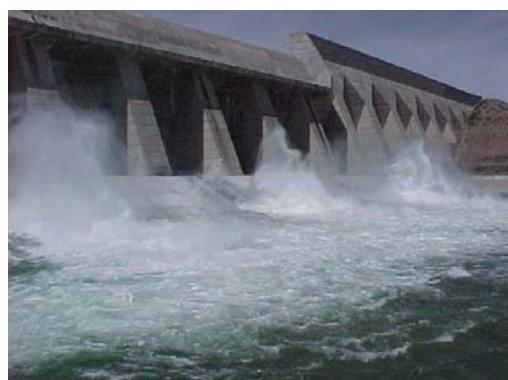
Full releases from Pueblo Dam to the Arkansas River following the completion of SOD work in 2000.

The modification work has had the anticipated effect and successfully addressed the sliding potential.

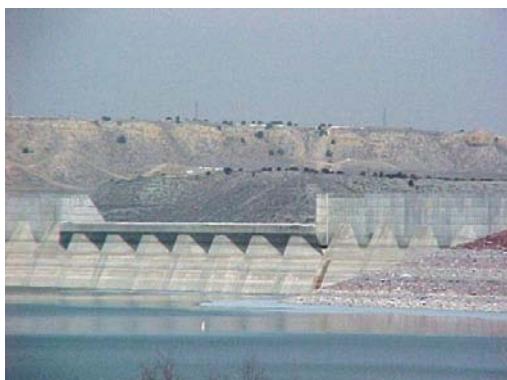
The concrete spillway section on the upstream side of Pueblo Dam.
